Traffic mortalities of the southern river otter and road-passes

Sotomayor Illezca Beatriz¹, Medina-Vogel Gonzalo², Diaz Mancilla Camila³, Solari-Romkema Camila³, Delgado Parada Nicole⁴ and Soto Ampuero Carla⁴

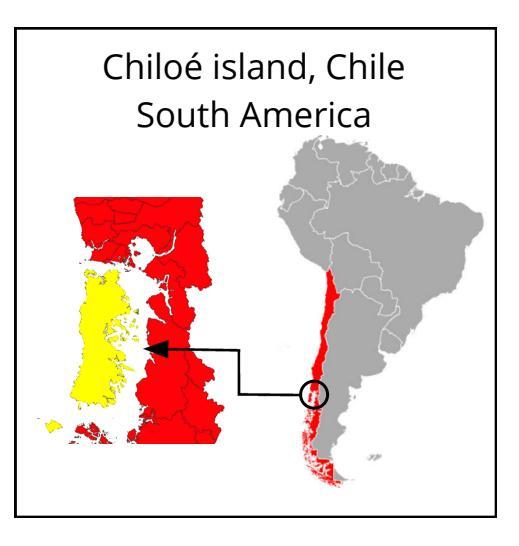
Road crossing Lake Tarahuín Chiloé island Los Lagos Region

culverts in the lower area, which triggered the first two accidents due to the collapse caused by the increase in water flow, causing the huillins to cross the road as the large torrent of water exceeds their swimming speed. On the other hand, next to the current road crossing of Lake Tarahuín are the rubble of the old road crossing, which was destroyed by the Chiloé earthquake. The cohabitation of huillíns and rodents in these ruins triggered the third accident, since the huillín, being a carnivorous animal, finds its prey in a more accessible way in the rubble found near the road.

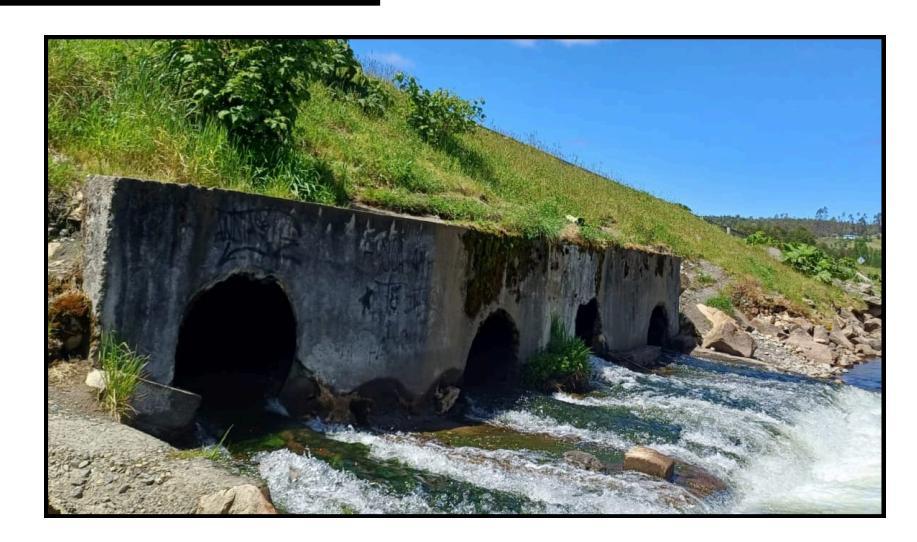
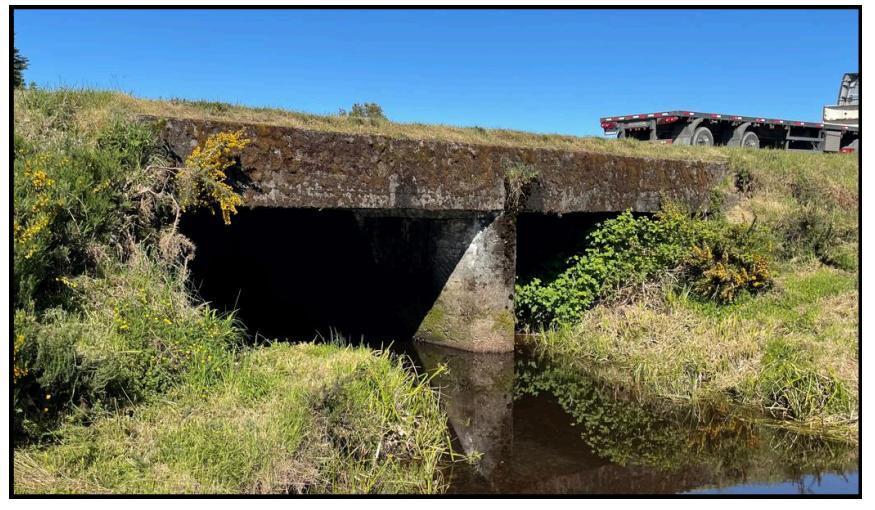
Vilcún River road bridge Chiloé island Los Lagos Region

A beam-type bridge located over the Vilcún River, in the Chiloé island, was studied. This type of bridge has a space in the lower area allowing the correct flow of water and at the same time provides a safer environment for the movement of the

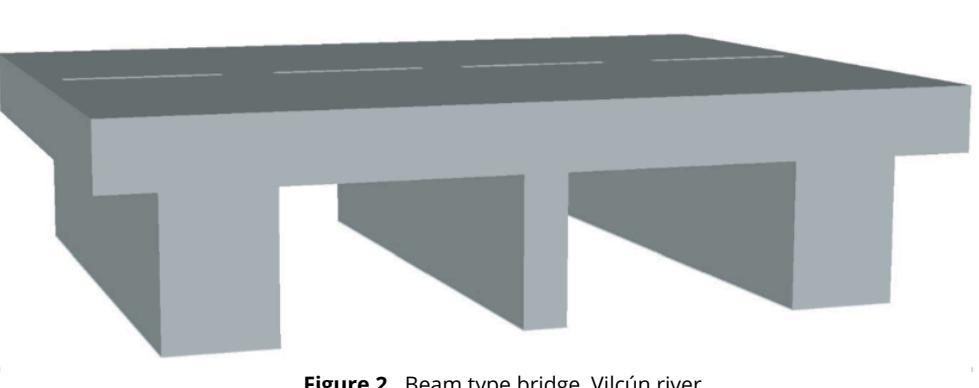
Figure 2. Beam type bridge, Vilcún river

species. This type of structure is a viable option to replace the road crossings where the accidents occurred since no limitations have been identified that could hinder the replacement of the road crossings with beam-type bridges. Therefore, implementing beam-type bridges and removing the debris located in Lake Tarahuín is essential to stop the accidents of huillines.
